Taken 1945.

Park Drain Outfall into  
Cross Drain.

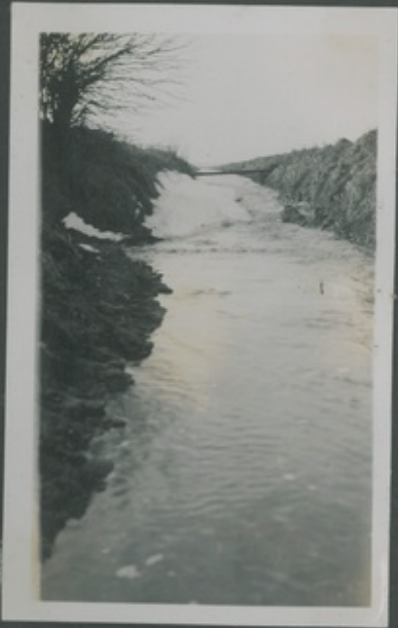
4'-0" fall in 1 chain  
caused by ice & snow.

The water level in Park Drain was  
only 12" below land, although there  
was a 4'-0" fall at the outfall, and  
this level was maintained for  
2 to 3 days.

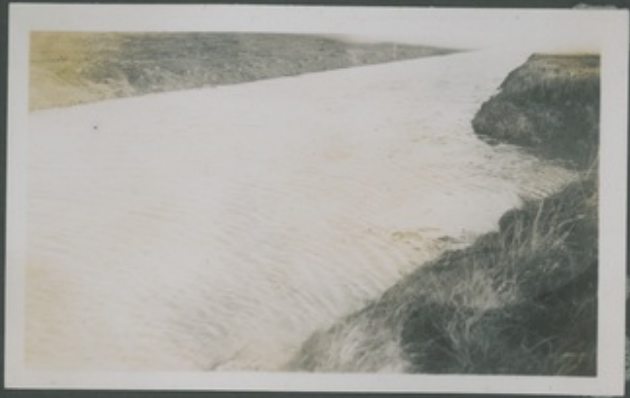
South Drove Drain at Crowland  
Common Outfall.

In Flood!
